LOI EXPERIMENTS:

May/June 2008 AT THE HALL 2

Y Irie and K Muto, KEK

Work Plan and Present Status

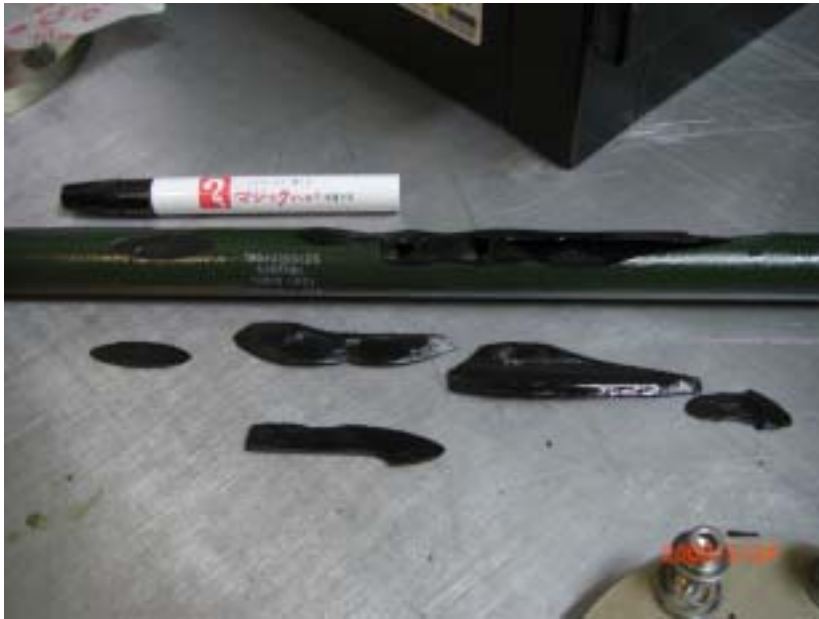
On May 23, Friday, insulation oil of the BR spurted out through its safety valve with a big sound.

- Inspected inside by lifting up the BR modules from the BR tank.
- Found,
 - (1) damping resistor is broken,
 - (2) flashover of the output capacitor between output terminal and capacitor chassis.

Broken damping resistor

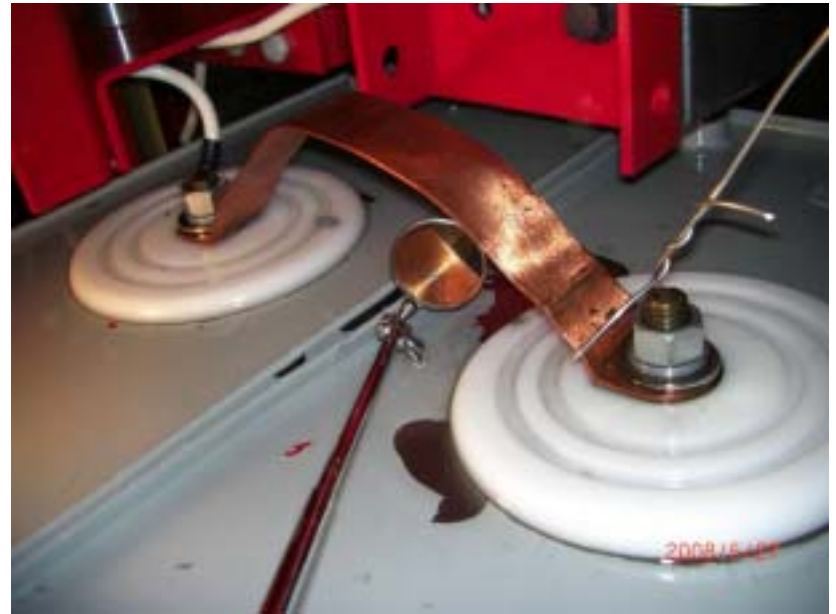
Flashover of the output capacitor

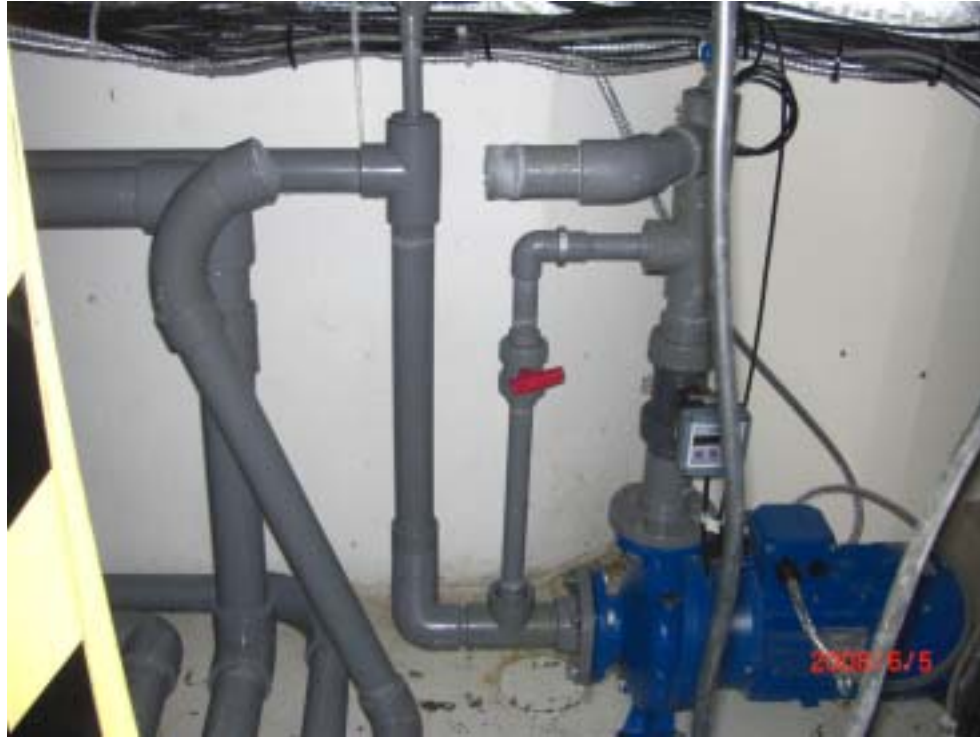
Water Leak

Vinyl chloride water-pipe came off for tetrode cooling
