## Weekly Progress Report

WPR003  
OKI Toshiyuki  
2004/06/01

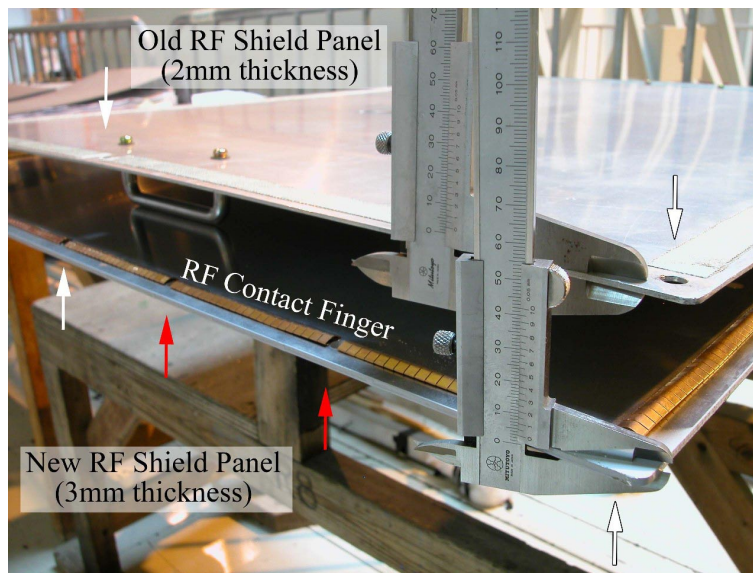
We had prepared the new RF shield panels, which has RF contact fingers and whose thickness is increased. The panel is shown in Photo 1, comparing with an old one. To set the panels on a RF chassis with enough RF shield, more holes were made on the panels. Then, steel frames of the RF chassis have been drilled as shown in Photo 2. Because 245 holes should be drilled and the steel frame has a thickness of 6mm, I will spend too much time for completing this work. However, I am now progressing steadily with this work.

Photo 1: New RF shield panel comparing with old one

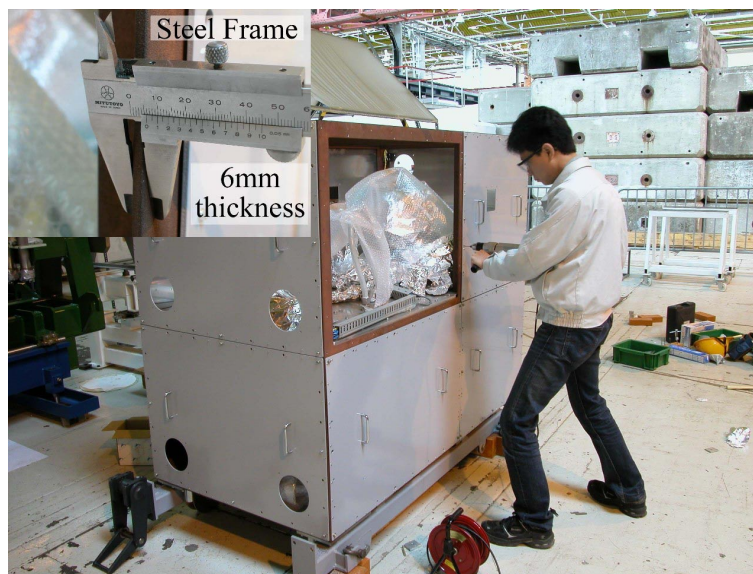
Photo 2: Work for new RF shield panels
