## Weekly Progress Report

WPR011  
OKI Toshiyuki  
2004/08/13

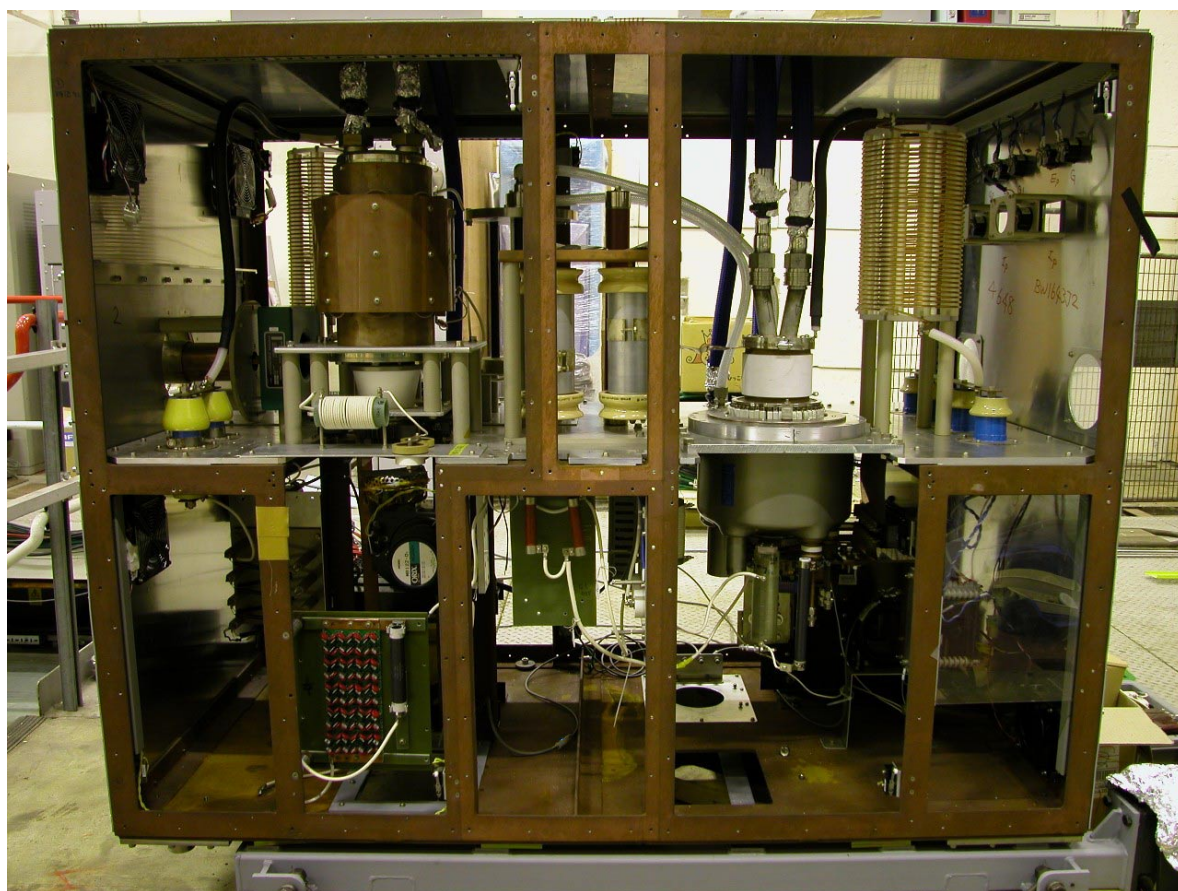
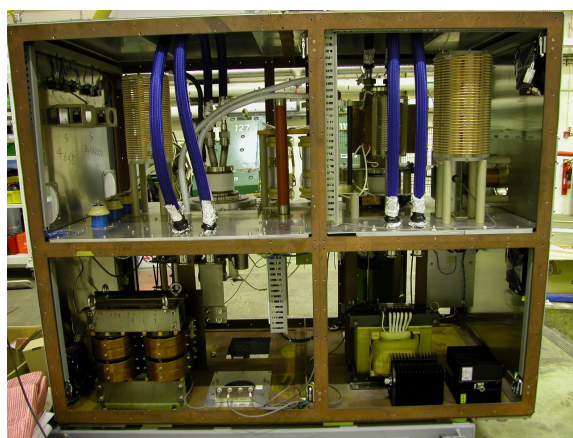
Some parts, such as cooling hoses, bus bars for filament of tetrode power tube, anode chock coils and electric parts, were attached to the HPD as shown in Photo 1. I readjusted a few part due to its wrong design. Although there was a problem in a space for E2V plate chalk coil, it was also attached.

Photo 1: HPD with some parts.
