A Beam Test of the Radiation Tolerance of the Au Coating on the Belle Beampipe

T. Abe^a, Y. Yamada^b and H. Yamamoto^a

December 27, 2001

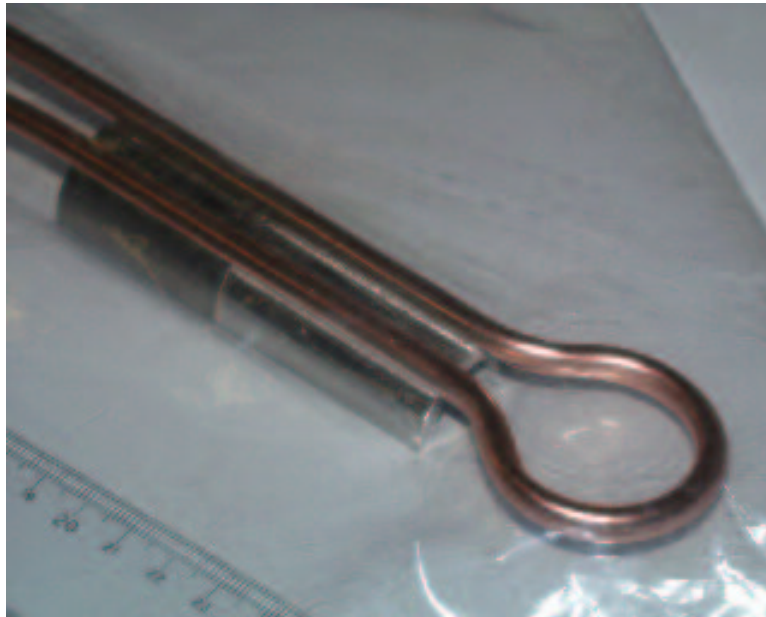
Figure 2: *The test piece with a cooling copper tube brazed on the outer surface.*

We used a test piece for the new Belle IR beampipe with a radius of about 1 cm and a length of about 10 cm. It consists of the tantalum (Ta) and stainless steel (SS) parts, with which we can investigate a possible difference between different materials of the beampipe. The test piece was cut in half lengthwise as seen in Figure 1, and one of them was used. A cooling copper tube was brazed on the outer surface by Ishikawajima-Harima Heavy Industries (Figure 2). Then an Au coating with a thickness of about $10\ \mu\text{m}$ was applied on the inner surface by ULVAC with a vacuum evaporation (Figure 3).

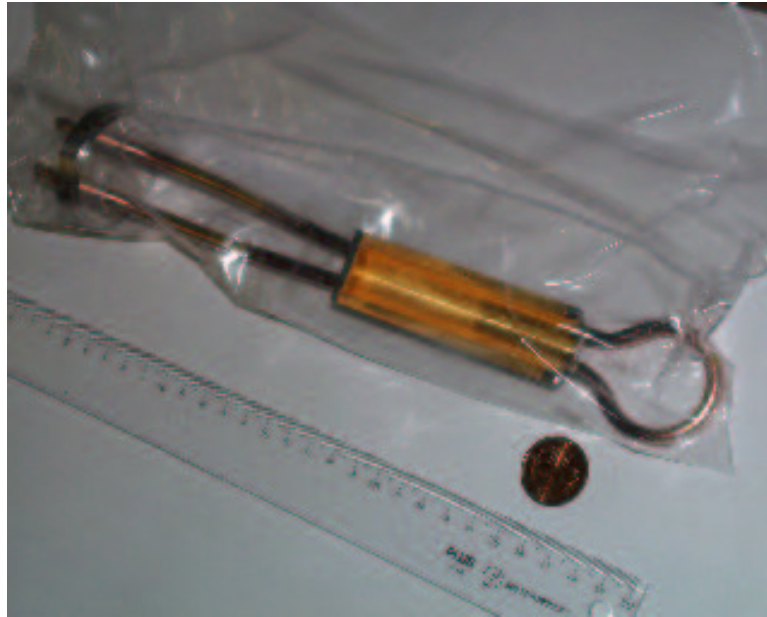
Figure 3: *The test piece with an Au coating on the inner surface.*

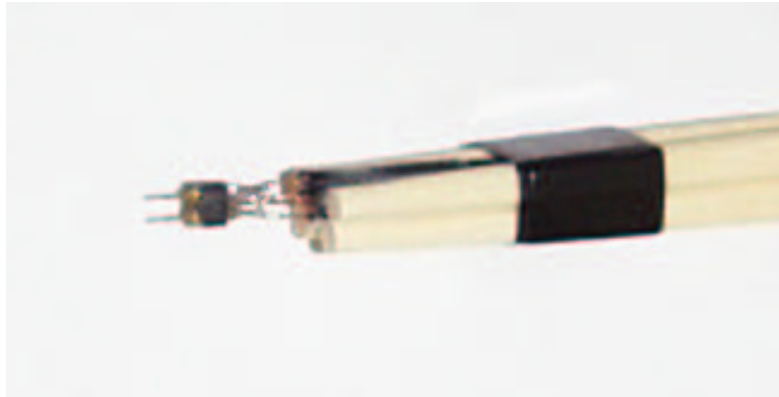
Figure 7: *The Au-coated pin head used as a probe in the resistance measurement. Two lead wires are connected to each pin for the four-wire measurement.*

The surface resistance was measured using an Au-coated pin head (Figure 7) and a digital multimeter (KEITHLEY2000) with a resolution of $0.1\ \text{m}\Omega$. We adopted the four-wire method in order to cancel the resistance in the lead wires and to obtain a better resolution. The pin head was fixed to an equipment and movable only up and down as seen in Figure 8, which made it possible to repeat equal measurements. Figure 9-(a) shows an example of measured resistance values as a function of time, and Figure 9-(b) shows the corresponding resistance distribution in the measurement

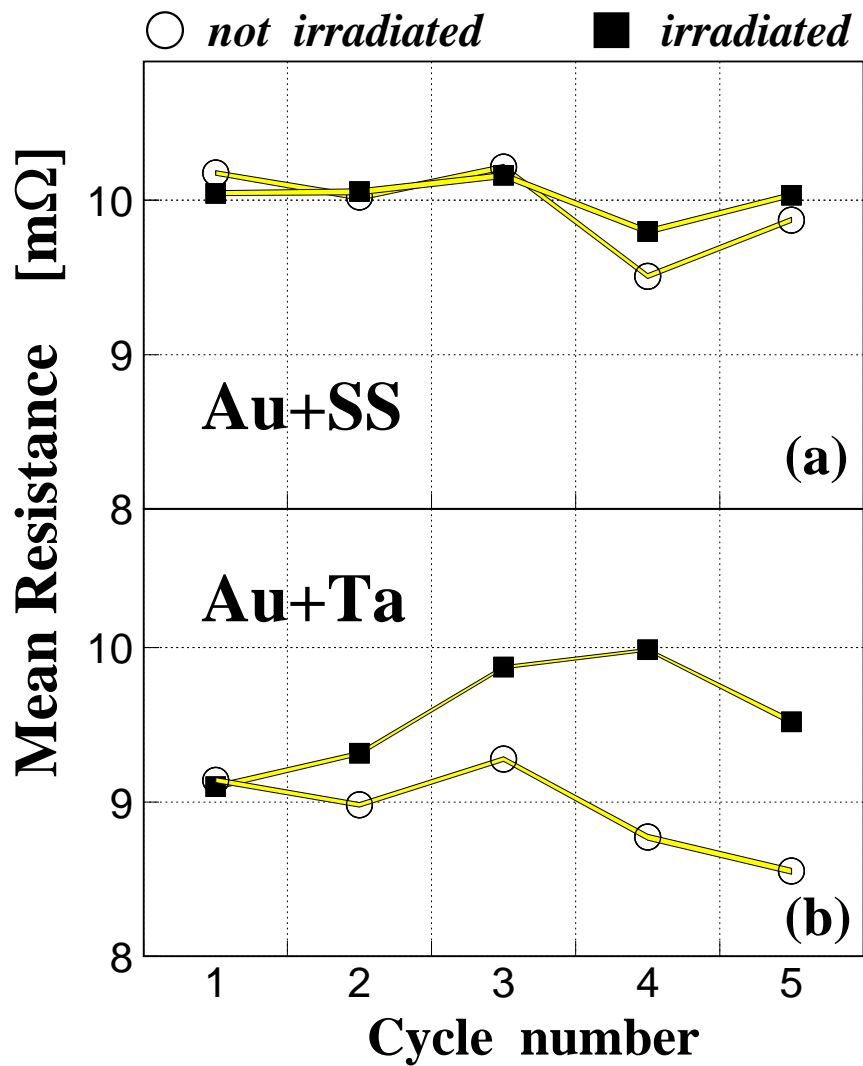
Figure 10: The cycle dependence of the measured mean resistances for the (a) SS and (b) Ta part. The bands indicate statistical errors of the fit.

period. Fitting the distribution with a Gaussian function, a mean value is obtained as a final one ($10.03 \pm 0.02 \text{ m}\Omega$ in this example). Such kind of measurement was performed at four different points: the (not) irradiated points in the SS or Ta part. Then the above procedure with four resistance measurements (“cycle”) was repeated five times to estimate the systematic error from the contact resistance between the pin head and the Au coating on the beampipe. The results are shown in Figure 10. The increase of the resistance due to the irradiation is defined as

where R' indicates a resistance at the irradiated point, and R_0 at the not irradiated point. With the above subtraction, we can investigate a change of the resistance of only the Au coating including the beampipe. Taking a minimum and maximum value for ΔR from all the possible combinations among the five cycles, values of ΔR are estimated to be:

$$-0.42 < \Delta R < +0.65 \text{ m}\Omega \quad \text{for the SS part and} \quad (2)$$

$$-0.18 < \Delta R < +1.43 \text{ m}\Omega \quad \text{for the Ta part.} \quad (3)$$
