# Accelerator Resonantly-coupled with Energy Storage

## 3-cavity system stabilized with the $\pi/2$ -mode operation

# Study on the TiN coating

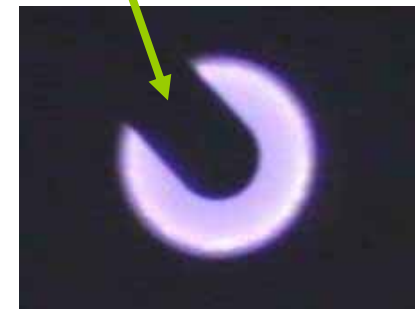
Example of the TV-camera snapshots of the *multipactoring* in the **coaxial line**

The problem is the *multipactoring* in the **coaxial line**.

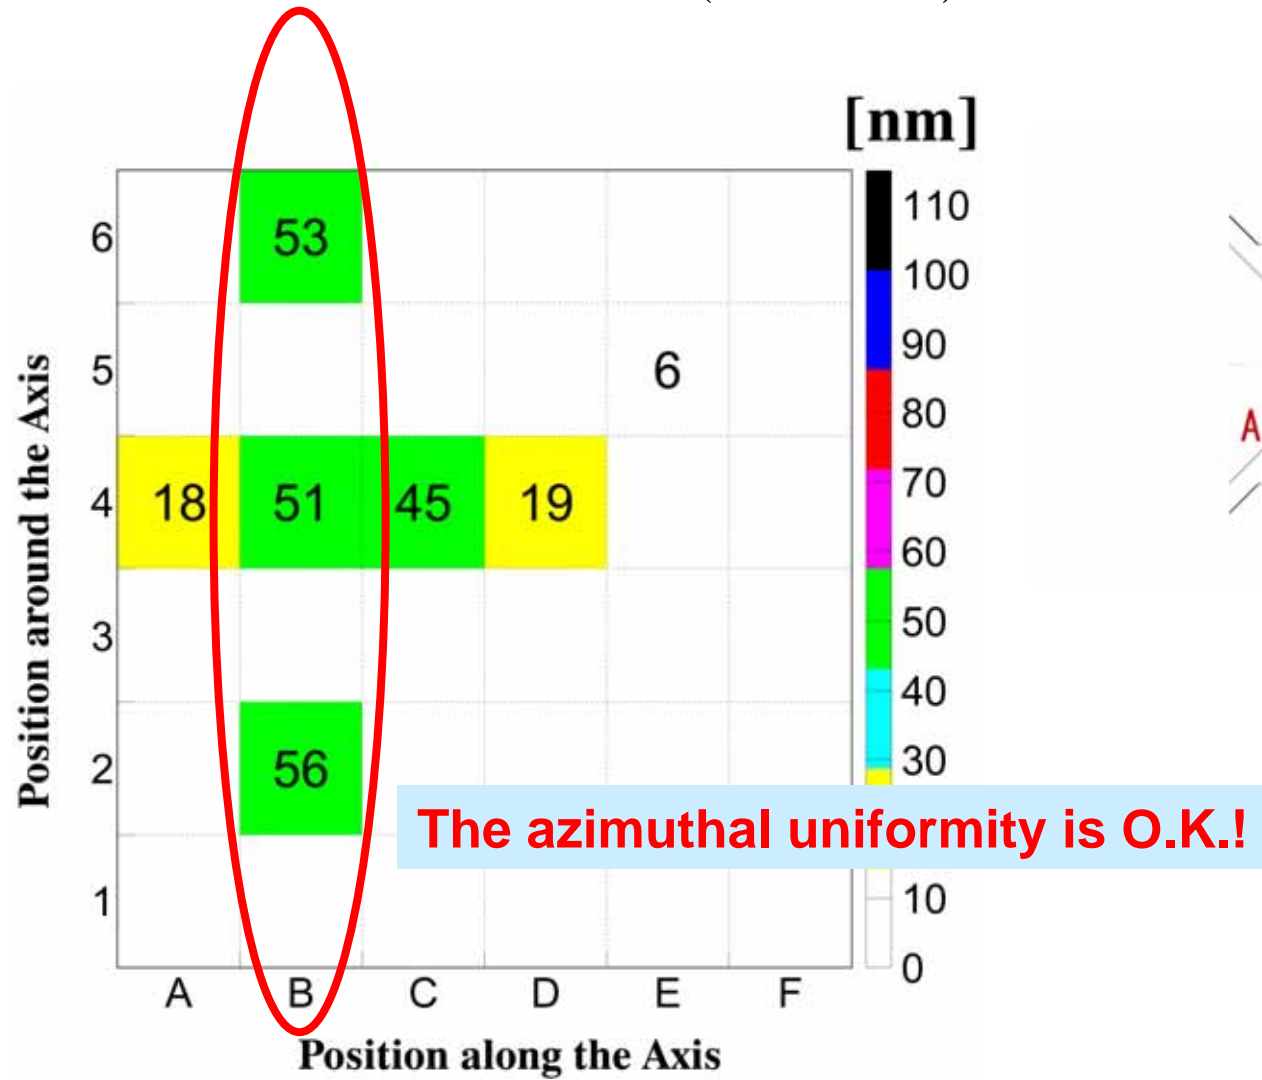
# Results of the TiN-thickness Measurement (2)

(Ar:N<sub>2</sub>=1:2)

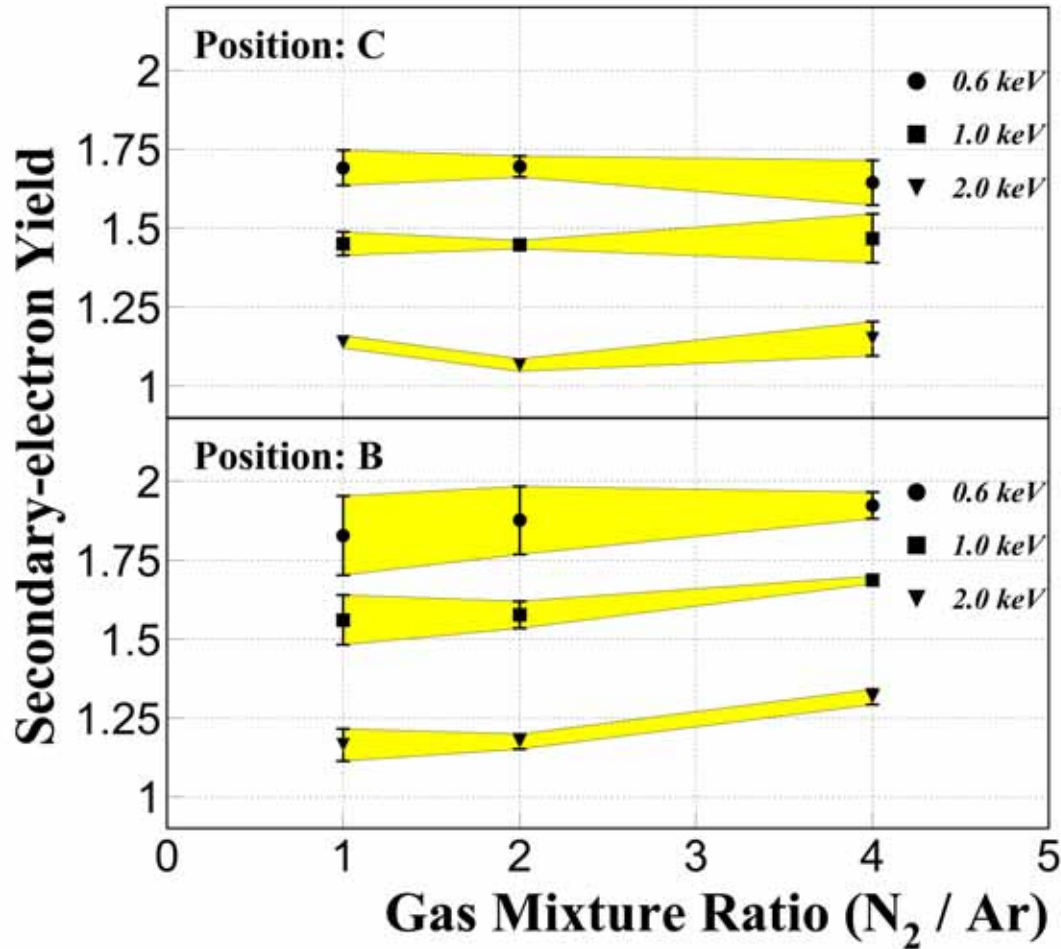
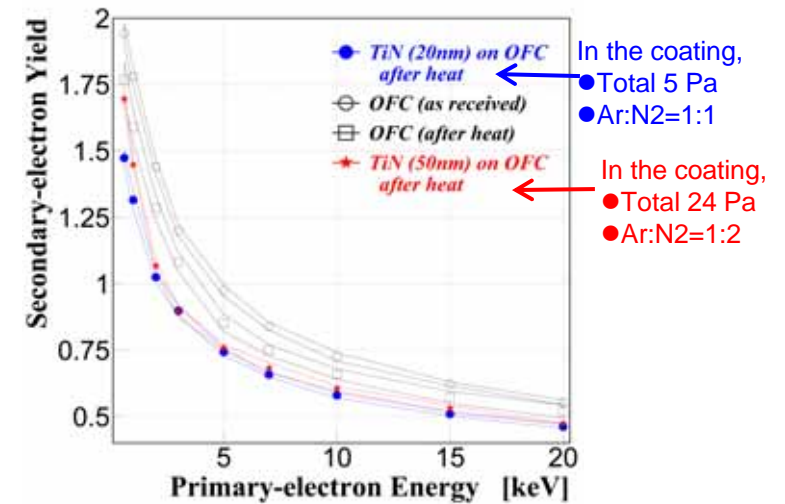
# Results of the SEY Measurements

→ No significant dependence on the gas mixture ratio!

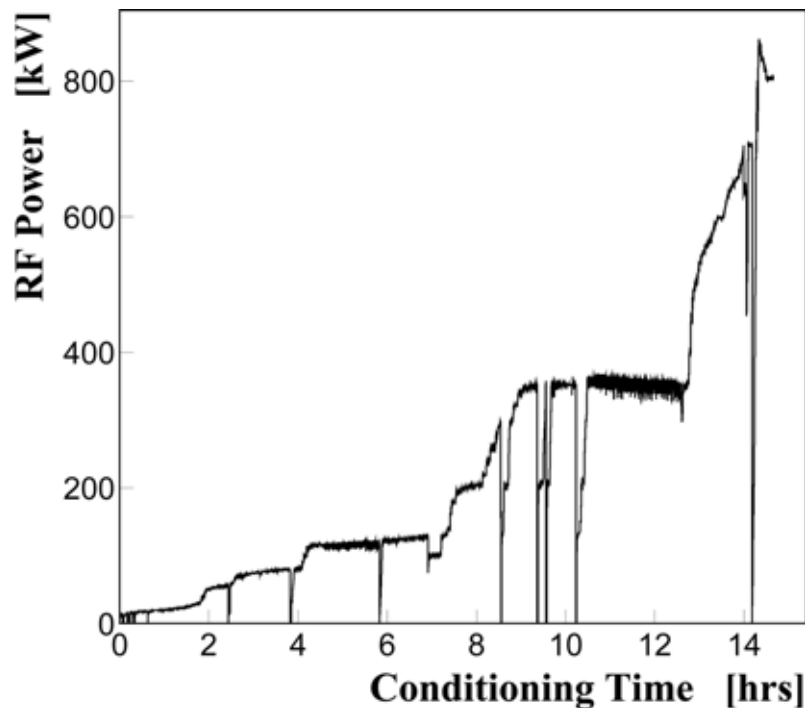
1<sup>st</sup>-tested TiN-coated coupler

→ No improvement so far compared to non-TiN-coated couplers
