LOI Progress Report

– First Experiment at the SP6 in November 2010 –

January 12, 2011

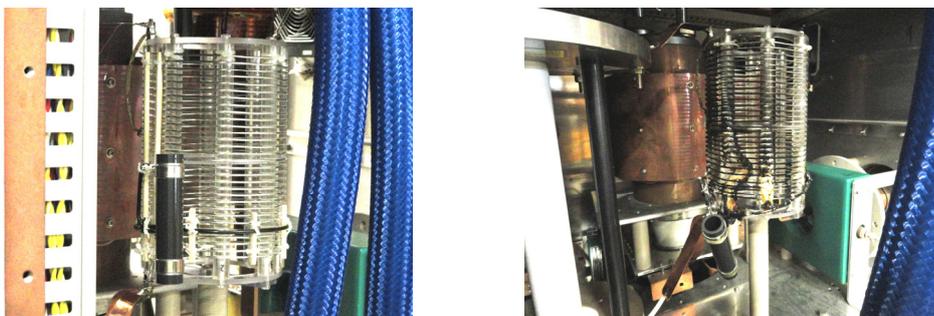
Although power dissipation of the damping resistor is decreased to 0.13, the new FBC was burnt again (fig.3). The reason of overheating will be misuse of the resistor. The resistor is the type of W-500D, power rating of which is 350~500W with water cooling. However, it was used without water cooling: rating is reduced to 50W without cooling. The burnt FBC was replaced with a new one (fig. 4): one-turn secondary coil with a 164 ohms, 300W resistor which is provided with forced-air cooling. Shorted turn number of the primary coil is 6. The impedance of the coil itself is shown in fig. 5.

Fig. 3 New feedback coil before RF on (left), which was burnt after RF test in November 20, 2010 (right).

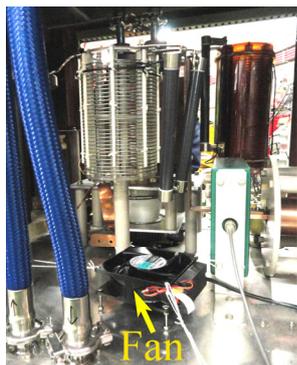
Fig. 4 Newest FBC with cooling fan.

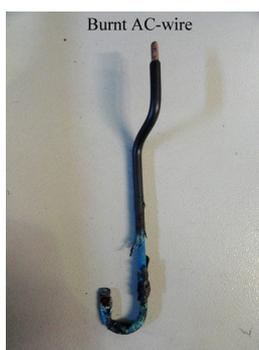
(1) AC line in the 100V switch board was found to be burnt on November 11 (fig. 11). This was due to a poor contact of the cable end: repaired on the next day.

Fig. 11
Burnt AC100volts circuit breaker and the AC wire.
