RF Accelerating Cavity for SuperKEKB Damping Ring and its Breakdown Study

Tetsuo ABE (KEK)

HG2015 Workshop at Tsinghua University, Beijing, China

2015-06-19

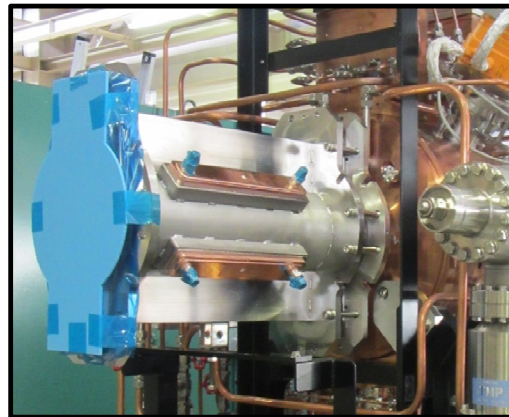
Grooved Beam Pipe (GBP) for damping:

- ✓ Horizontally-polarized dipole modes

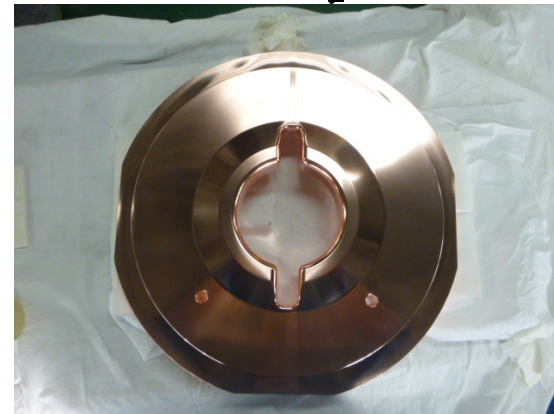
After EP

$R_a=0.2\mu\text{m}$, $R_y=1\mu\text{m}$ ($< \delta = 3\mu\text{m}$)

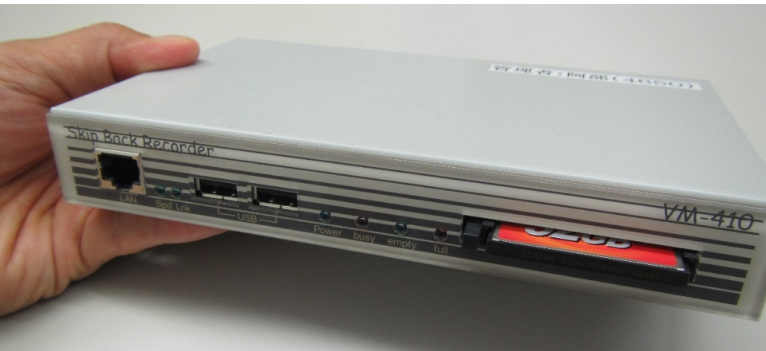
Skip Back Recorder

- ✓ OS: Linux
- ✓ Input video: NTSC
- ✓ Trigger: RF switch “ON → OFF”

All of the cavity-breakdown events recorded automatically (5 seconds before, until 1 second after this trigger)

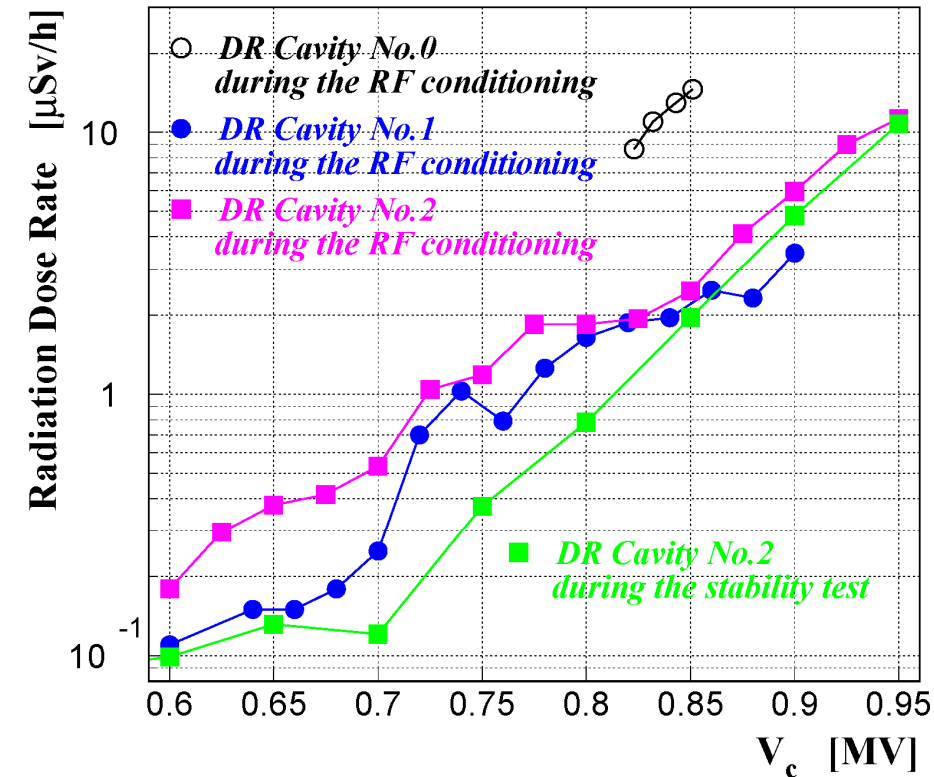
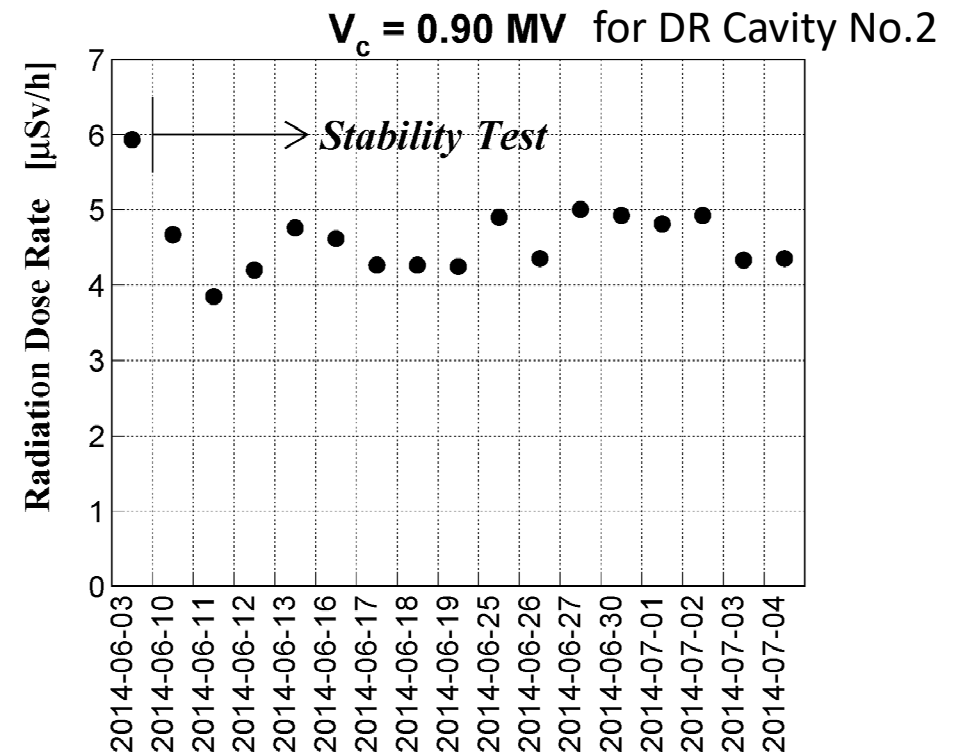
Radiation Dose Rate

= Indirect observation of the dark current:

Field emission

→ Acceleration

→ Impact on the inner surface

→ Emission of X-ray

No significant difference between DR Cavity No. 1 and No.2

Constant during the stability test (20 cavity breakdowns in this period)

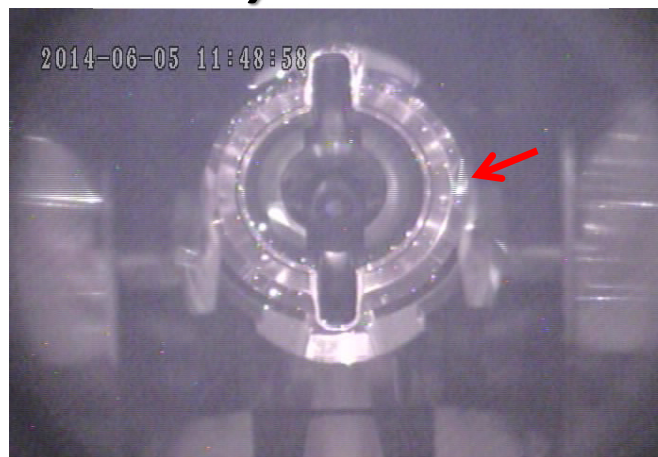
Example of Cavity-Breakdown Events (3)

Spot-type explosion of a bright spot which had kept its intensity until the explosion, followed by disappearance

$$V_c = 0.95 \text{ MV} (E_{\text{acc}} = 3.7 \text{ MV/m})$$

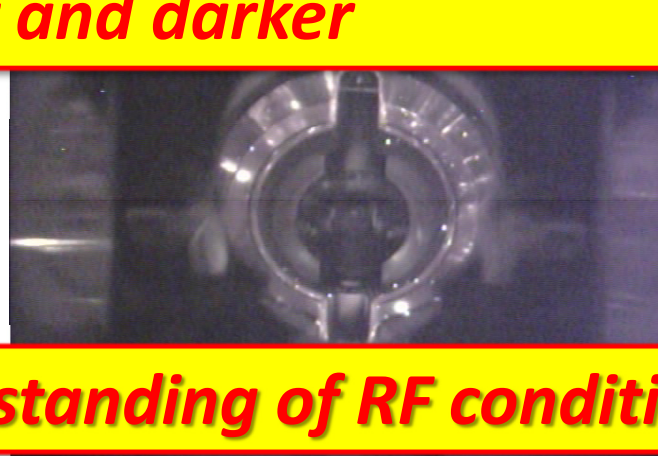
Bright Spots @ $V_c = 0.90$ MV ($E_{acc} = 3.5$ MV/m)

✓ Decrease in the number of bright spots
✓ Darker and darker

Visual understanding of RF conditioning effects!

- Even after the RF conditioning (during the stability test with keeping $V_c = 0.90$ MV)
- We have discovered that decrease in the number of bright spots after explosion is a **significant component of RF conditioning** of the cavity.

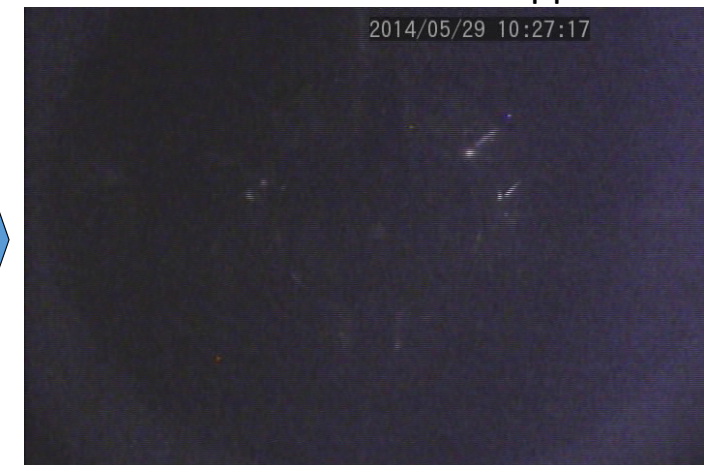
Example of Cavity-Breakdown Events (6)

$$V_c = 0.80 \text{ MV } (E_{\text{acc}} = 3.1 \text{ MV/m})$$
