RF Accelerating Cavity for SuperKEKB Damping Ring and its Breakdown Study

Tetsuo ABE (KEK)

[KEK Preprint 2015-25](#)

MeV Arc Workshop at Ivalo, Lapland, Finland

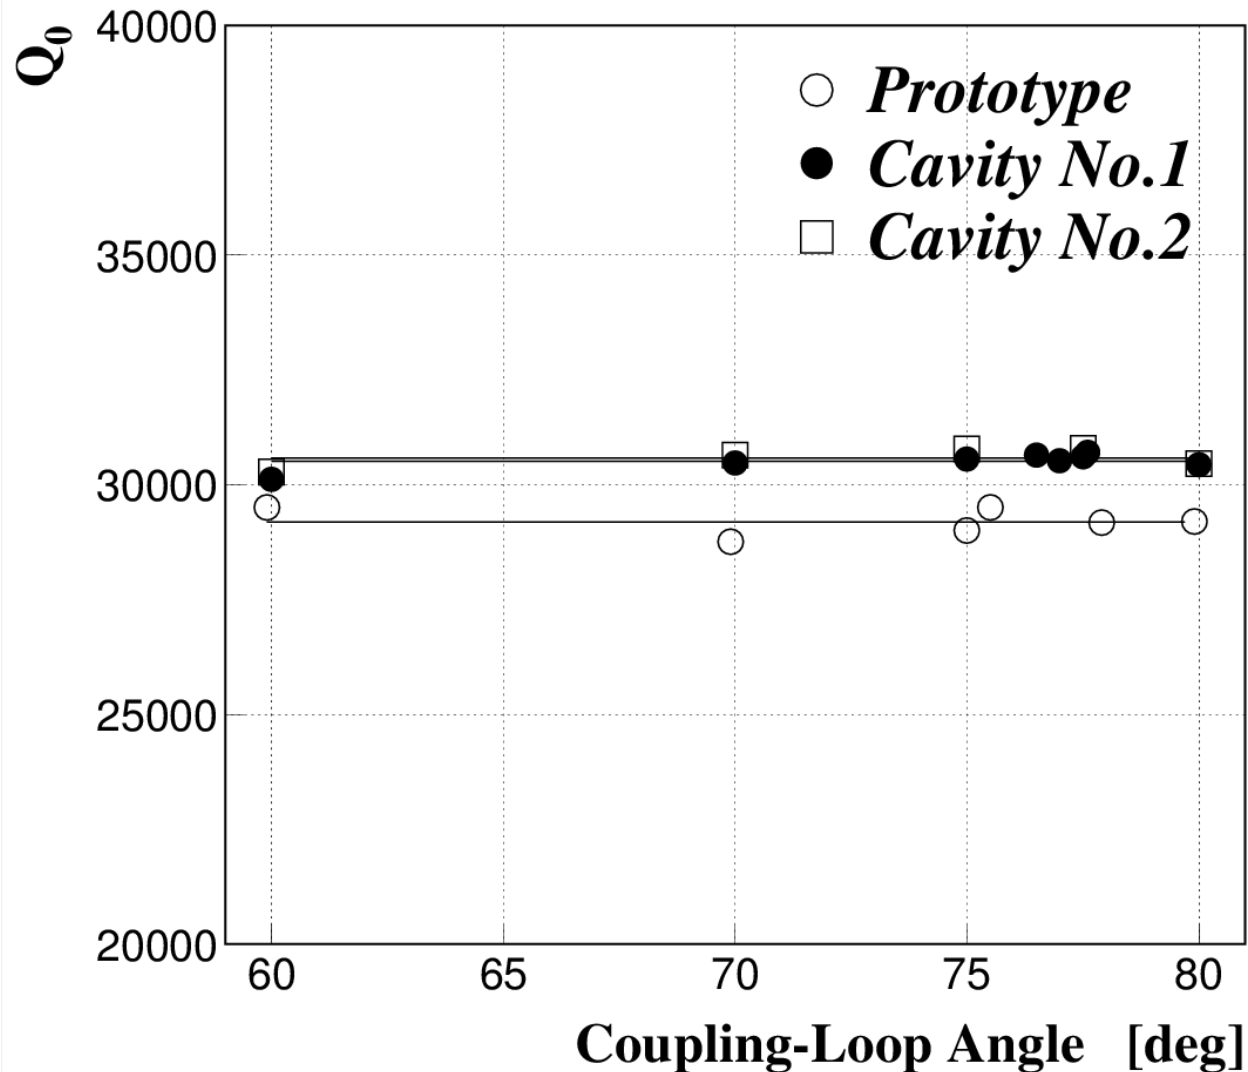
Low-Power Measurements of Unloaded Q-factor (Q_0)

$Q_0(\text{meas}) / Q_0(\text{sim})$
Prototype	92.9% IACS
Cavity No.1	97.1% IACS
Cavity No.2	97.3% IACS

4% improvement with EP

(Note: No EP applied to the barrel)

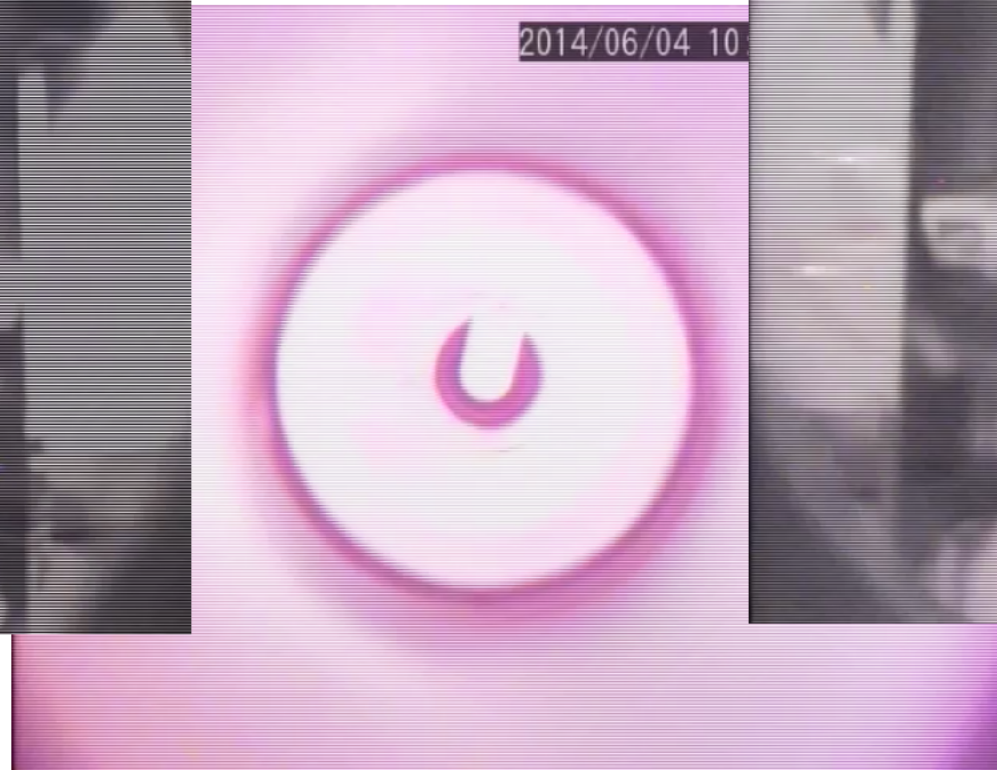
Example of Cavity-Breakdown Events (2)

Flash(2) $V_c = 0.89 \text{ MV}$ ($E_{acc} = 3.5 \text{ MV/m}$)

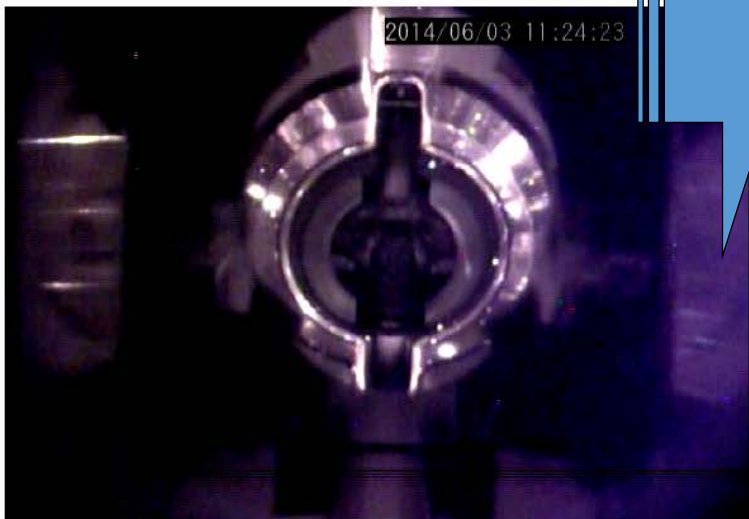
Bright Spots @ $V_c = 0.90$ MV ($E_{acc} = 3.5$ MV/m)

During RF Conditioning

At the beginning of the stability test

At the end of the stability test

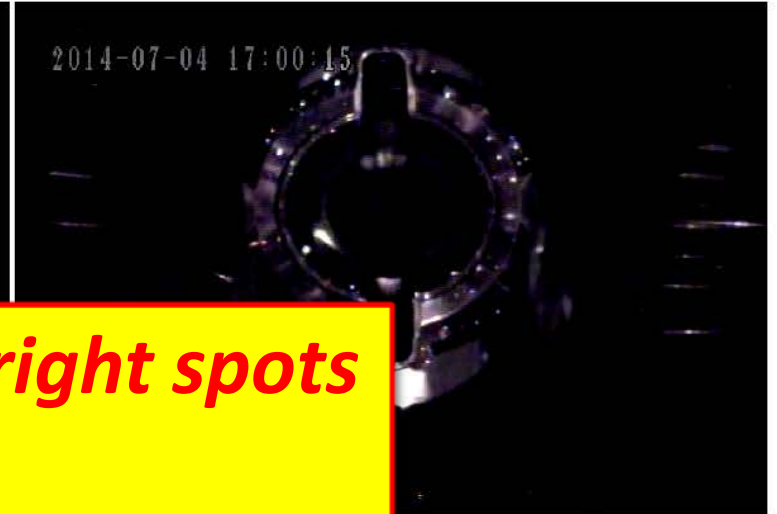
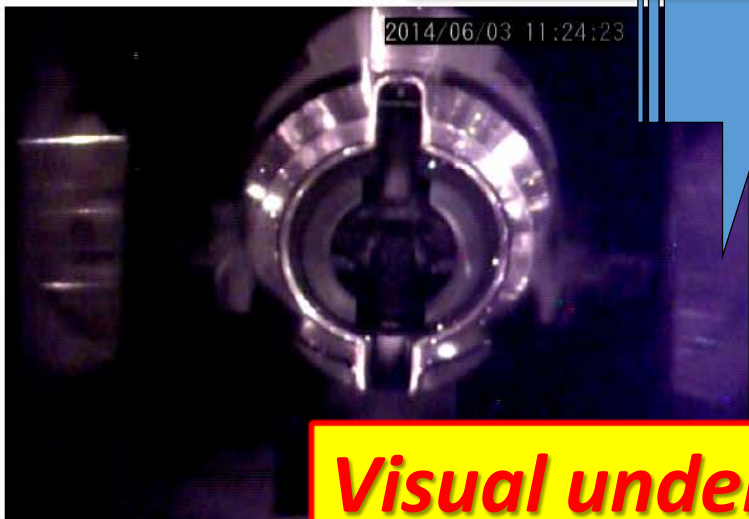
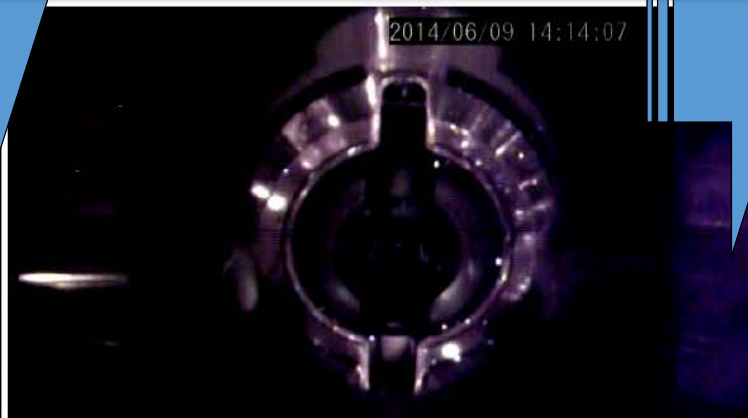
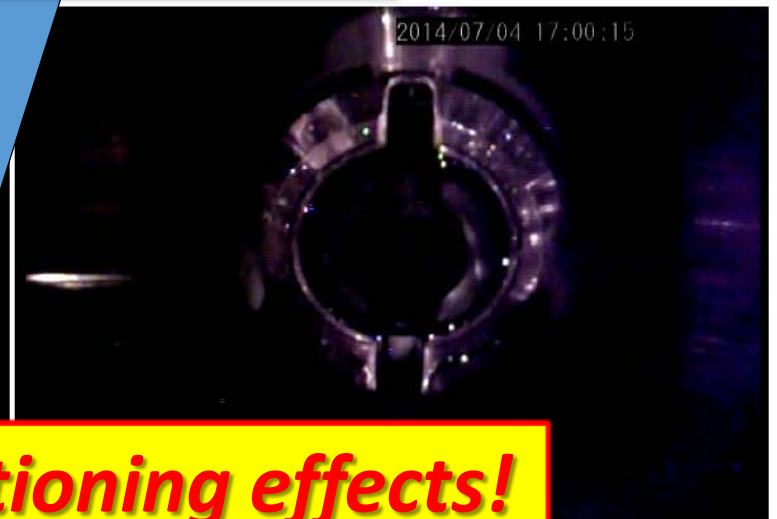
Bright Spots @ $V_c = 0.90$ MV ($E_{acc} = 3.5$ MV/m)

✓ *Decrease in the number of bright spots*
✓ *Darker and darker*

Visual understanding of RF conditioning effects!

- Even after RF conditioning (during the stability test at $V_c = 0.90$ MV)
- We have demonstrated that decrease in the number of bright spots after explosion is a **significant component of RF conditioning** of the cavity.

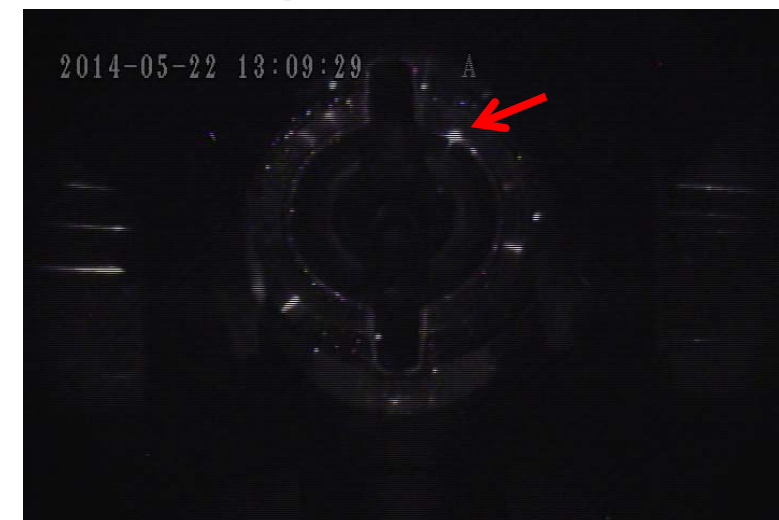
Example of Cavity-Breakdown Events (5)

Spot-type explosion w/o a bright spot which had kept its intensity

$$V_c = 0.56 \text{ MV} \quad (E_{\text{acc}} = 2.2 \text{ MV/m})$$

A new bright spot appeared!

Cavity Breakdown!

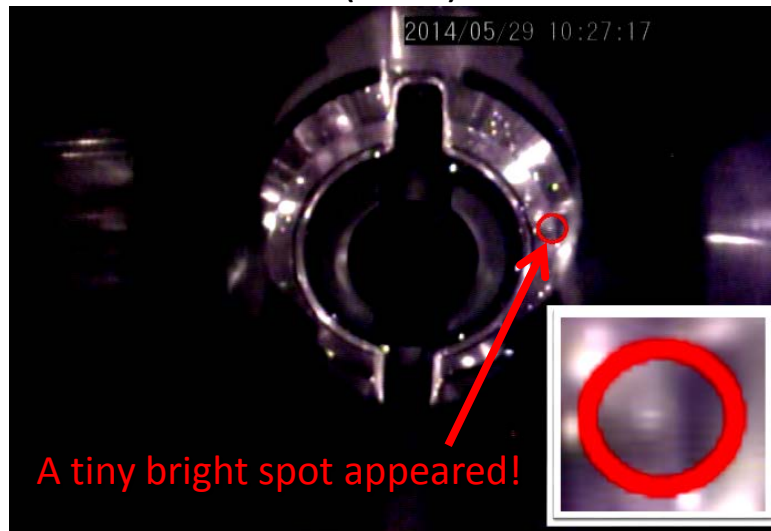
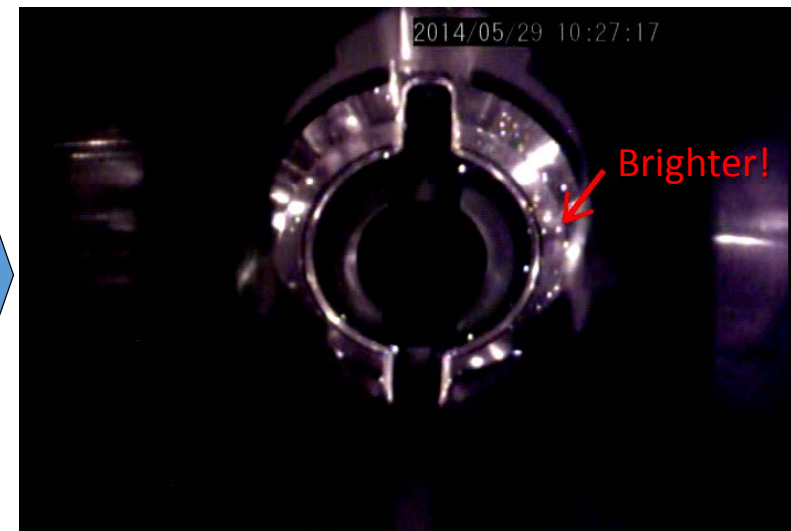
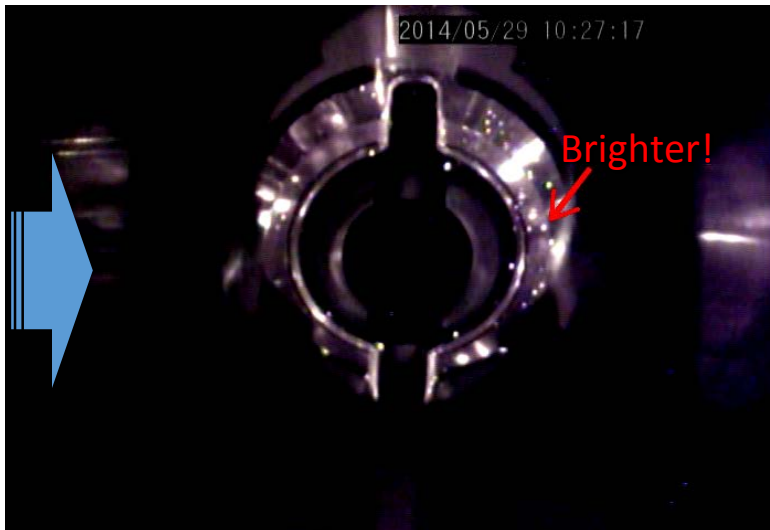
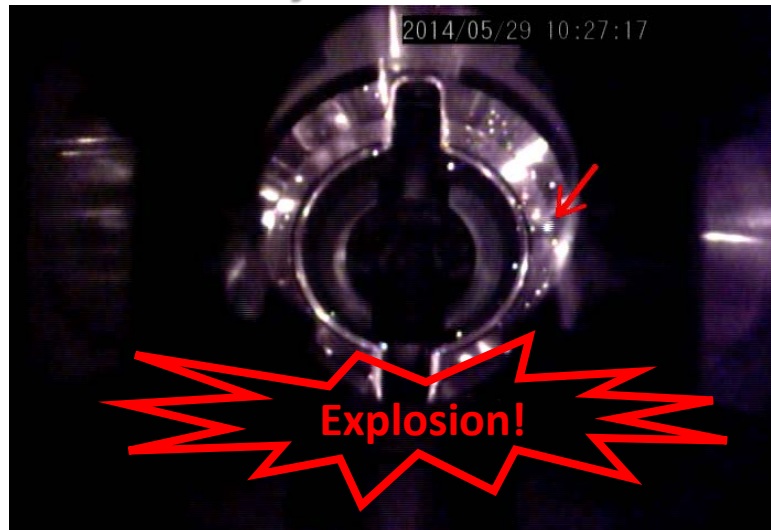
Example of Cavity-Breakdown Events (6)

$$V_c = 0.80 \text{ MV} (E_{\text{acc}} = 3.1 \text{ MV/m})$$

Cavity Breakdown!
