Behaviors of thinned 2.5x2.5mm² sensors

26 Dec. 2006

T. Tsuboyama (KEK)

Thinned PIXEL and STRIP

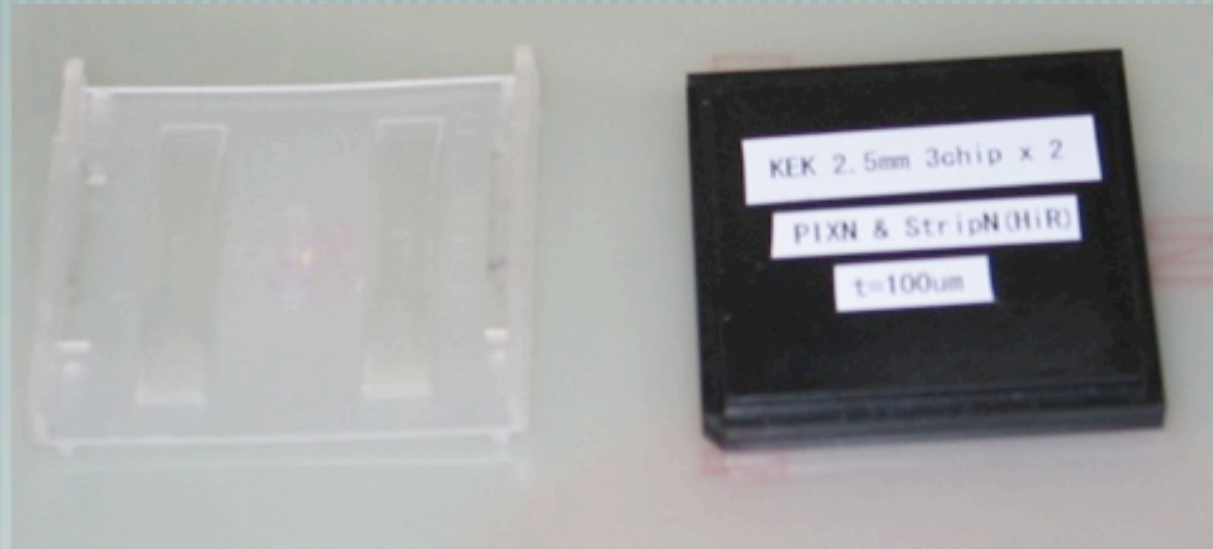
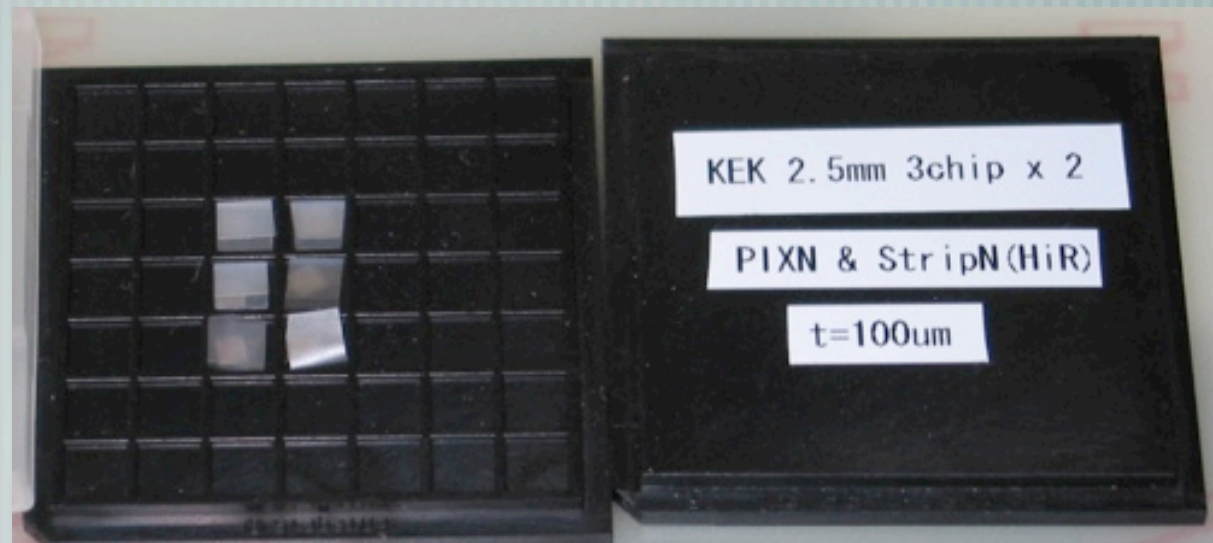
On 21 Dec. 2006,
I received the
package.

Package is OK.

The surface is dirty

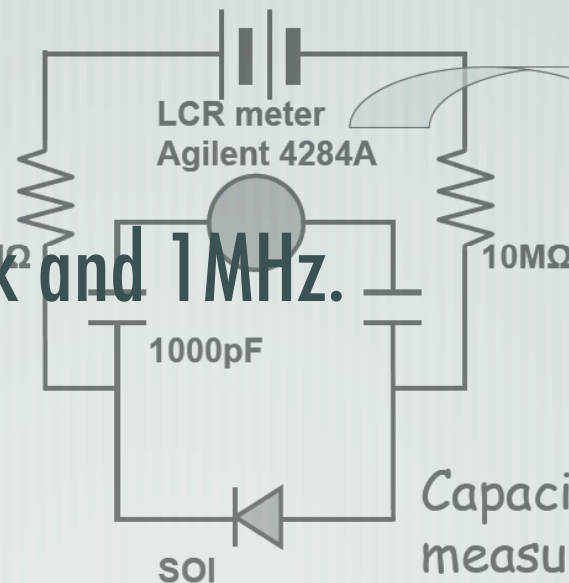
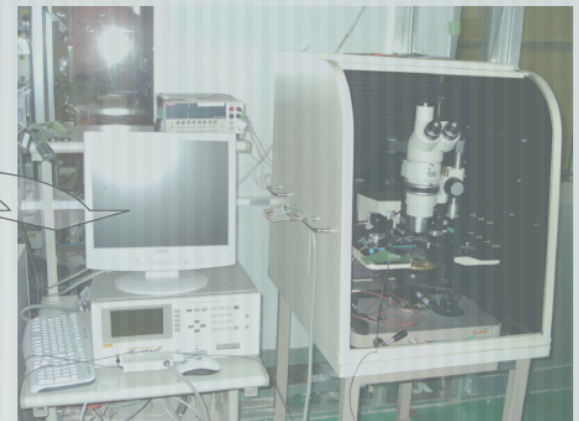
Test setup

Set up is same as that of Miyake.

Type 1 of the strip is measured.

Amplitude=0.1 V

Freq.=1k, 10k, 100k and 1MHz.

Capacitances are independently measured for type-5 and type-1

Freq. 10KHz
Level: 100mV

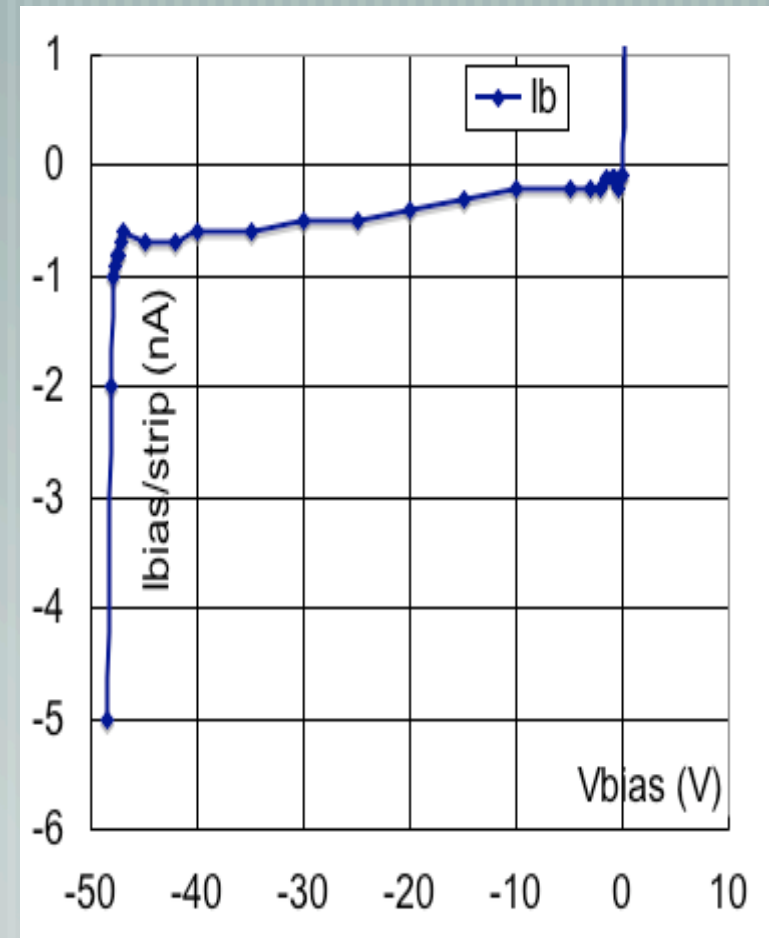
26 Dec. measurement (I-V)

The tendency and absolute value is much similar to that measured by Miyake.

Breakdown voltage is -45 V.

The small fluctuations are due to long damping time of the bias current.

- [Breakdown voltage: 60 V before thinning, 45 V after thinning.

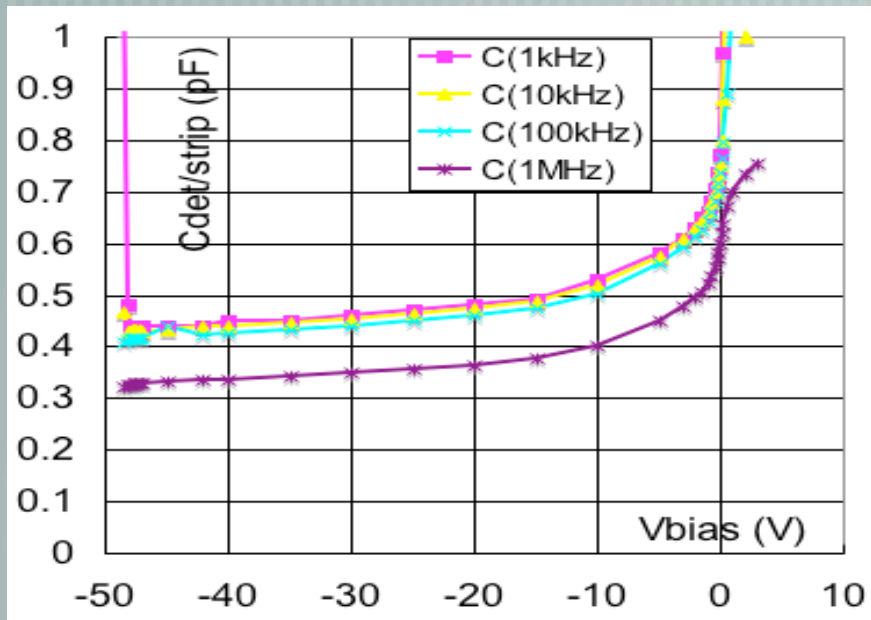
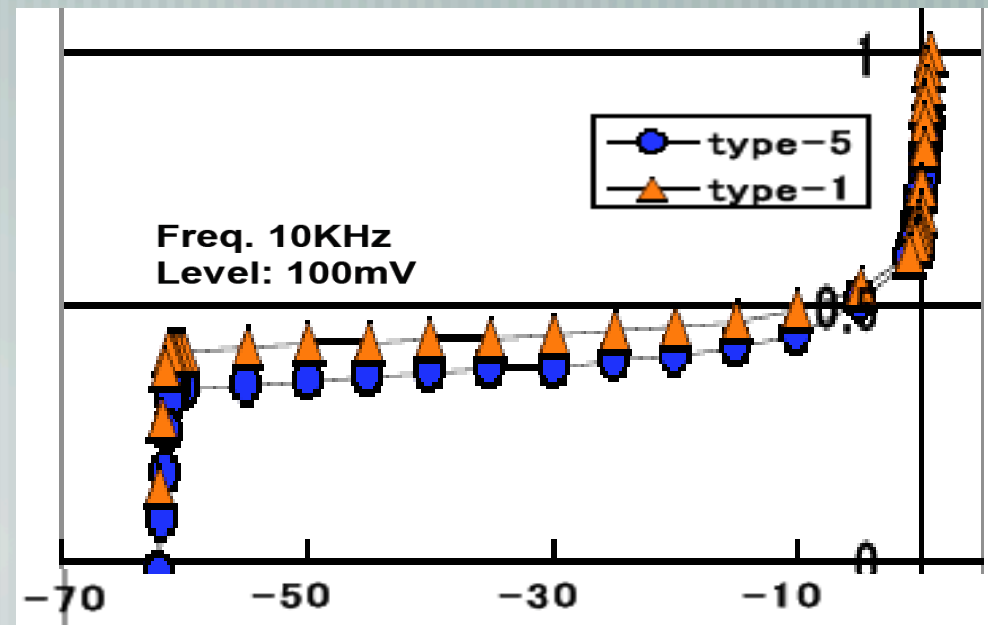
26 Dec. measurement (C-V)

- The capacitance behavior is also same as that of Miyake.
- The capacitance is still decreasing at 50 V.
- The 100 $\mu\text{m-t}$ substrate is not fully depleted at 50 V.

- [Detector capacitance at given bias voltage is same.

- The substrate seems not fully depleted at the breakdown voltage.

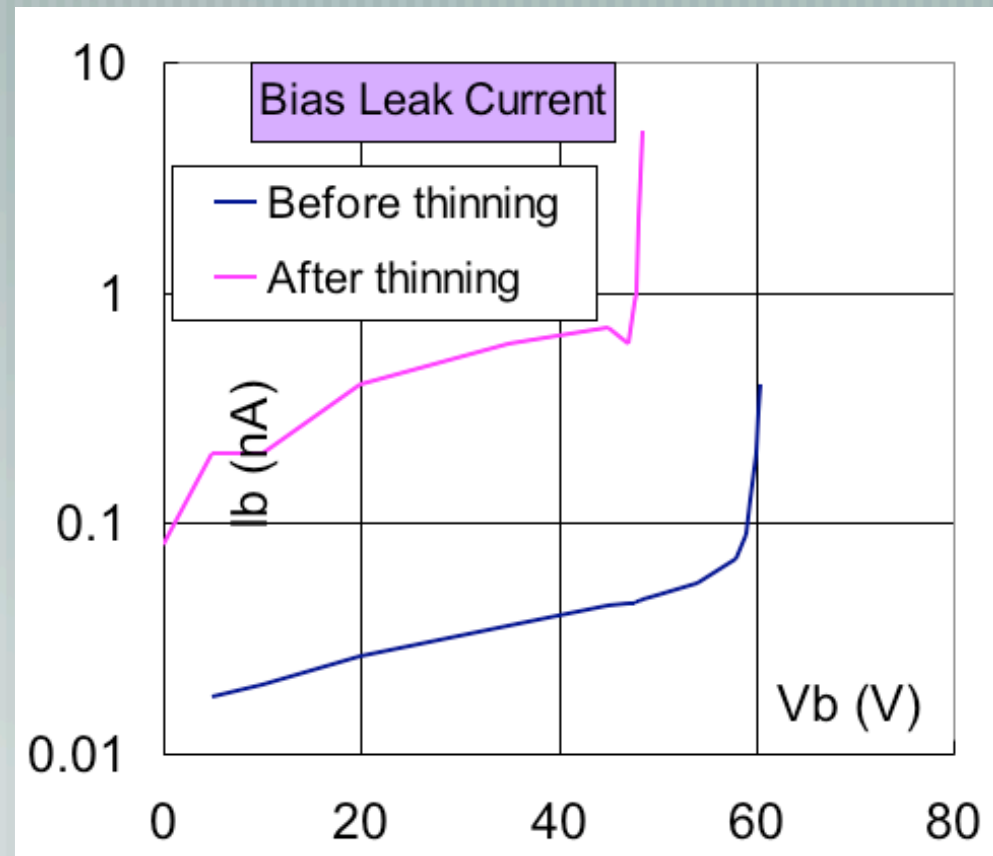
Erratum in 5 Jan 2007

I found the unit of I-V curve in Miyake's measurement is 1/10 than I thought. The I-V curves before and after the thinning are plotted here.

In summary, the leak current increased significantly in the thinning process.
